## Interim report on the investigation of the explosion and fire on board the chemical tanker *Stolt Groenland* on 28 September 2019, Ulsan, Republic of Korea

### NARRATIVE

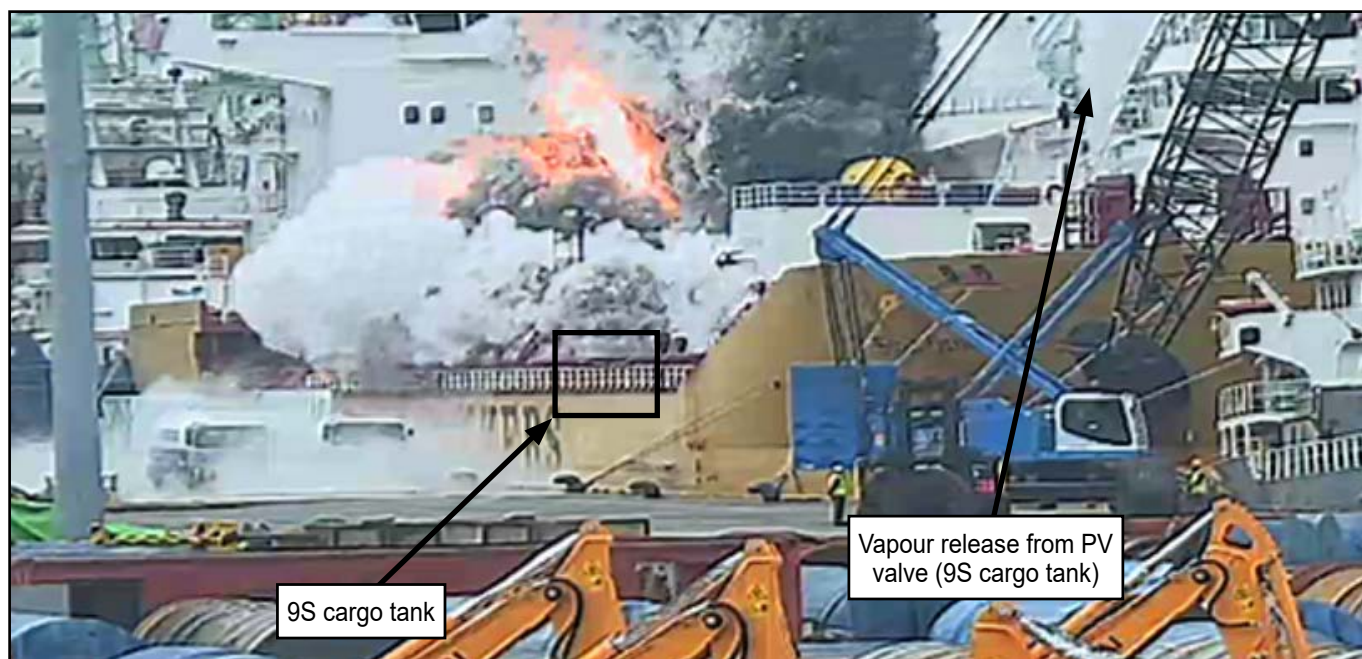
At 1043, vapour started to release from the pressure vacuum valve for *Stolt Groenland's* number 9 starboard (9S) cargo tank, which contained styrene monomer. About 2 minutes later, a high-level alarm indicated that the level in 9S cargo tank had reached 95%, soon followed by a high-high-level alarm indicating that the level had increased to 98%. By now, *Stolt Groenland's* on-watch deck officer and chief officer had made their way to the cargo control room and they saw from the cargo monitoring system that the pressure inside 9S cargo tank was rapidly rising. Suddenly, at 1050, two explosions were seen and heard in rapid succession in way of the tanker's cargo manifold (**Figure 1**). The resulting fireball passed very close to a road bridge above the quay (**Figure 2**).

**Figure 1:** Tank rupture and ignition of released vapour

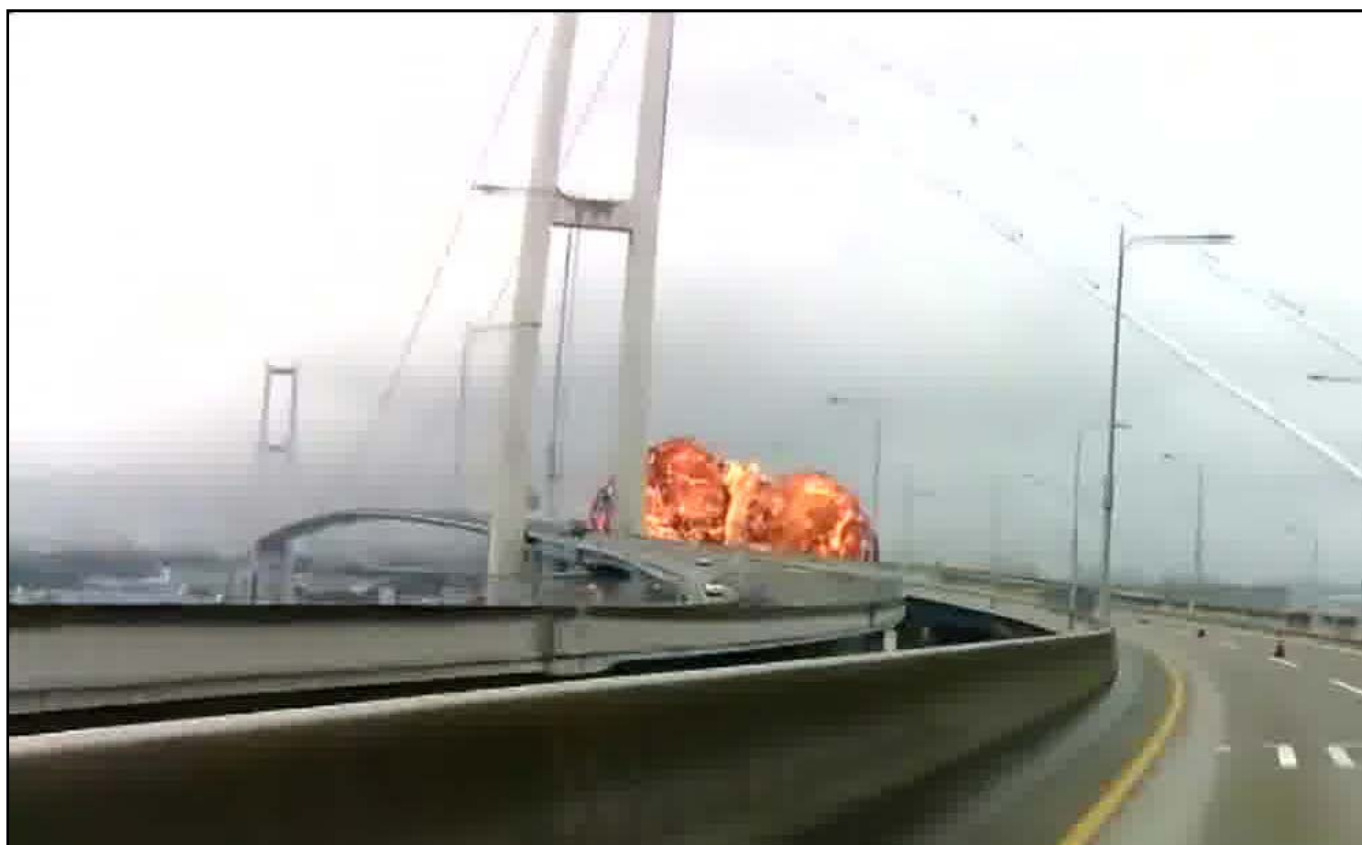
**Figure 2:** Fireball viewed from the Ulsan bridge

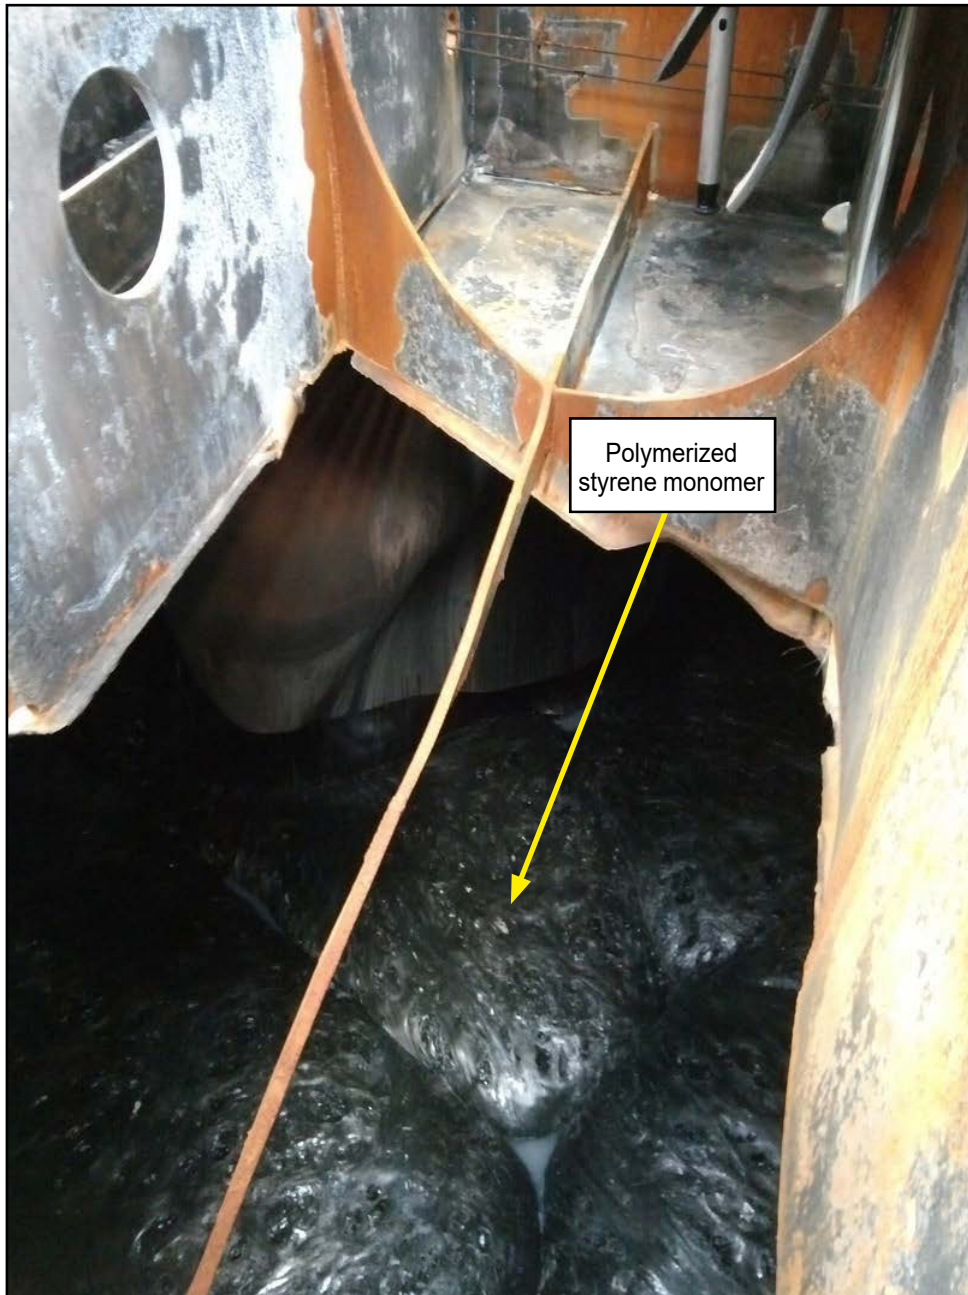
The explosions on board *Stolt Groenland* were probably caused by the rupture of the deck above 9S cargo tank, followed immediately by the ignition of the styrene monomer vapour that was then released. The rupture was due to over-pressurisation and the likely sources of the ignition were static electricity, sparks or elevated steel deck plate temperatures resulting from the tank rupture. A large hole was found in way of the tank's common bulkhead with number 9 centre (9C) cargo tank (**Figure 4**) and its hatch cover had been blown off. No cargo operations or deck maintenance were in progress at the time. VDR data showed that the temperature of the styrene monomer had reached 100°C at the time of the explosion. Such an elevated temperature indicates that the cargo was polymerizing.

**Figure 4:** 9S tank rupture
